Agricultural Lot Boundary Re-establishment by the 1949 Aerial Photograph

Dr CONRAD TANG
Hong Kong Delegate to FIG Commission 7

ZHANG Ran
Department of Land Surveying & Geo-Informatics
The Hong Kong Polytechnic University
September , 2008

- ◆ Provide the best accurate boundary determination (1m) in the disputed field-bund boundary (3m) between Lot 1169 & 1170RP in DD 106

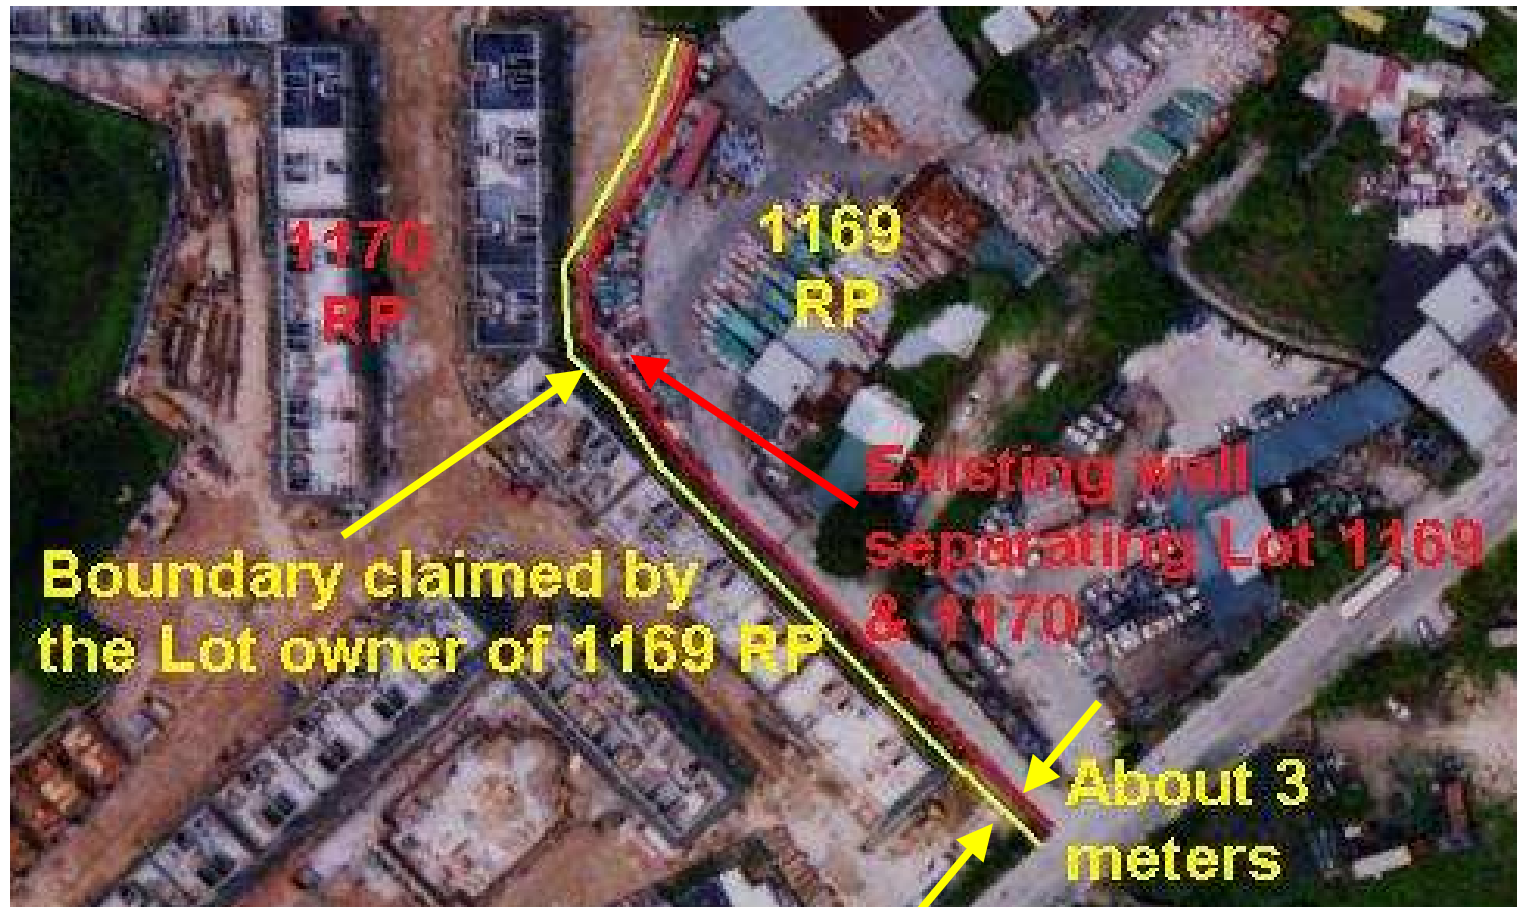
Aerial photo in 2005

Dispute overview

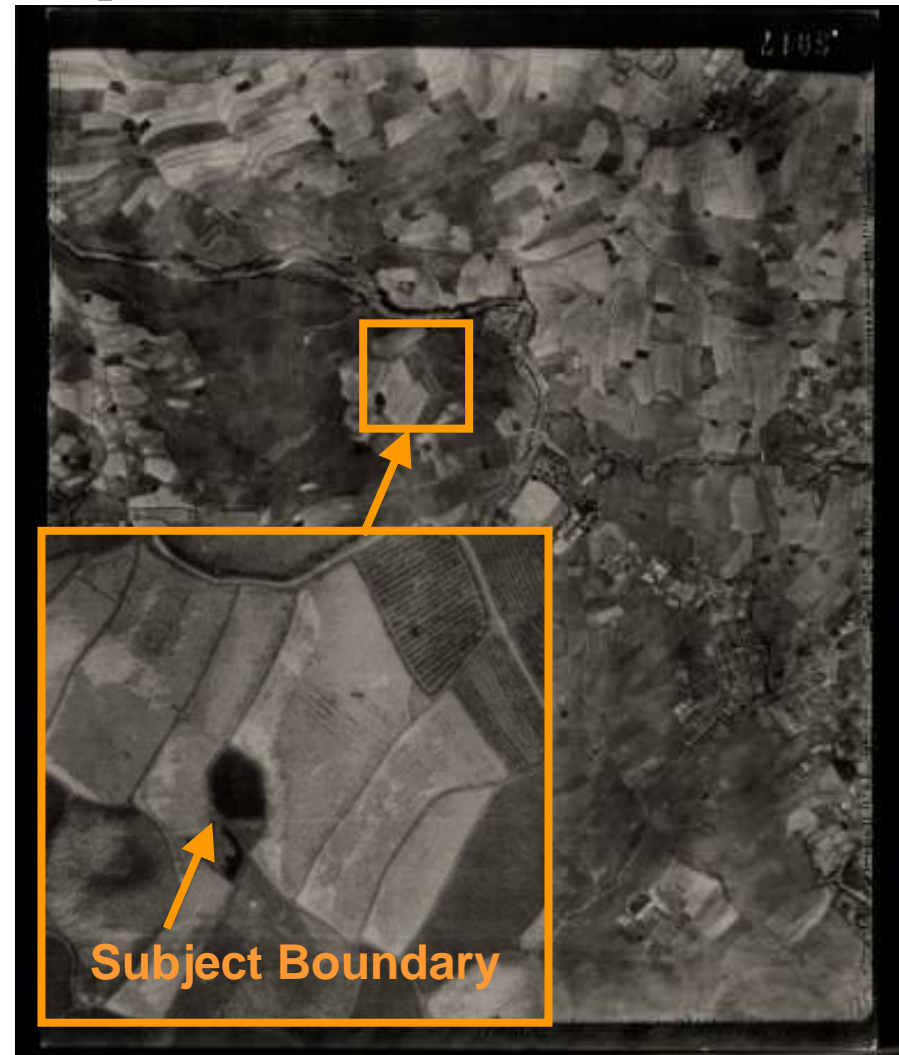
1949 Aerial photograph

10" by 10"

large format

No.6016 & 6017

no interior

orientation parameters

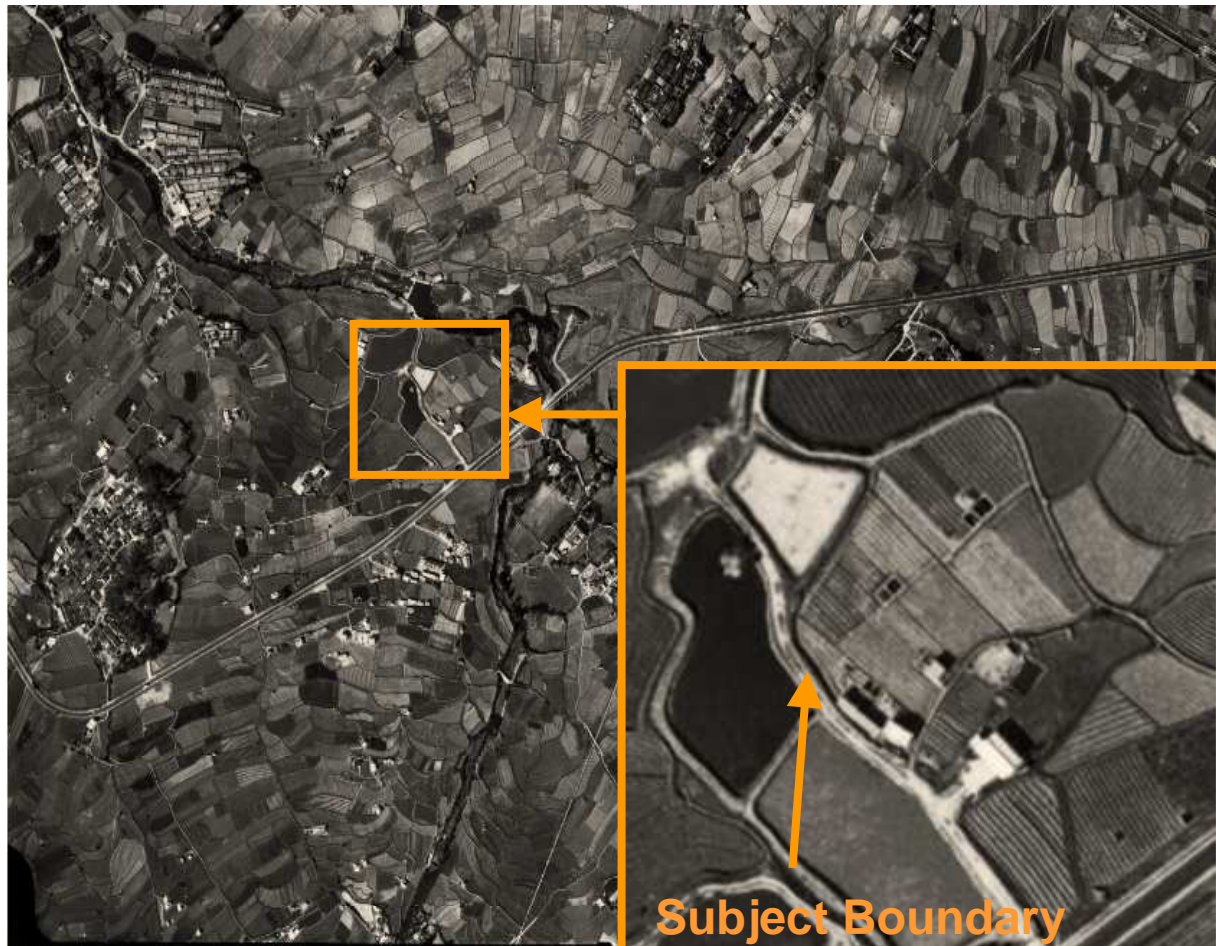
1963 Aerial photograph

Aerial Photo
Large Format
No.8398
of 1963

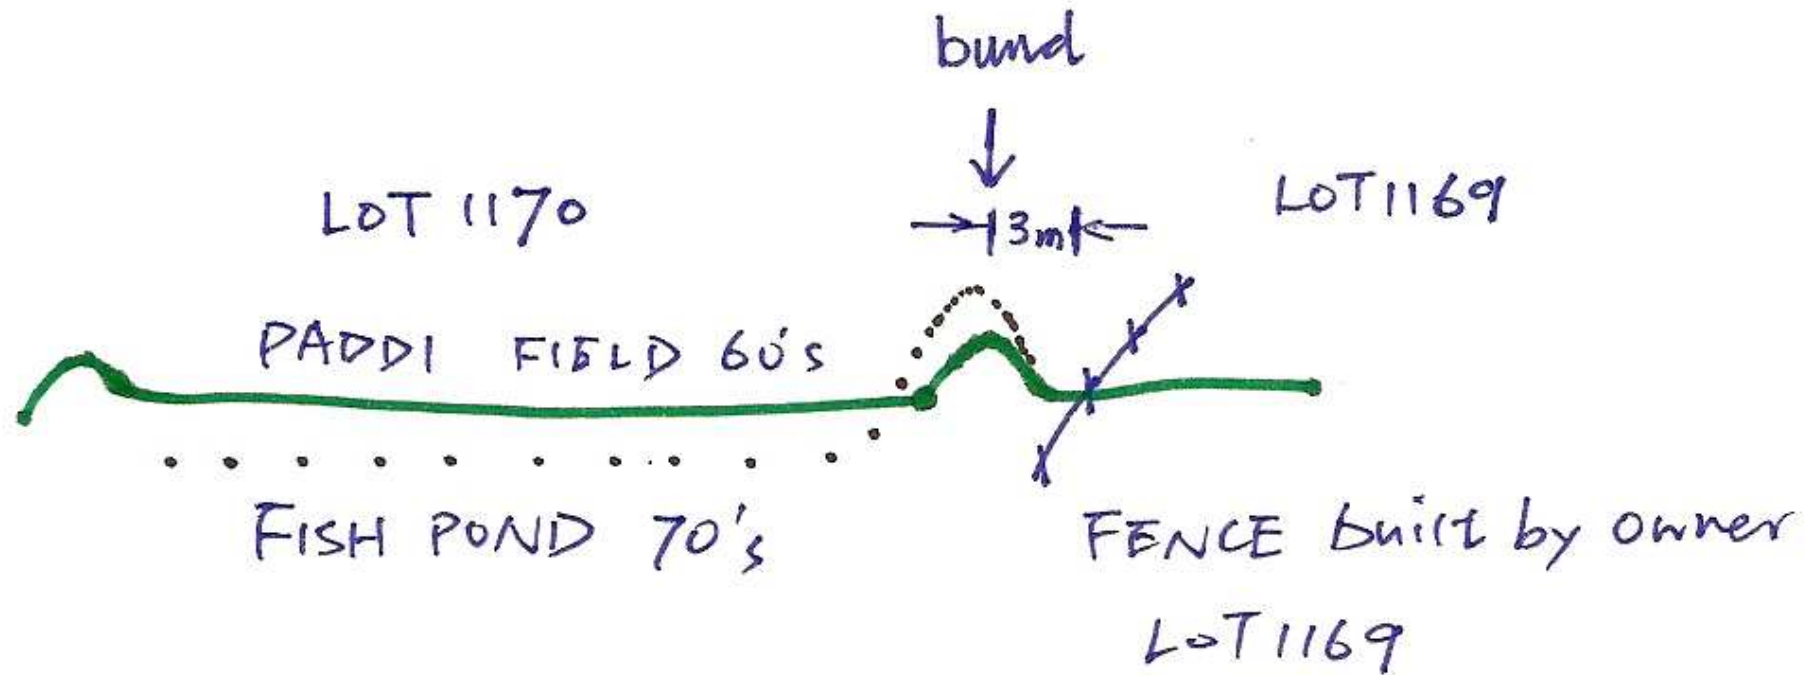
1985 Survey Sheet

U, V, W & AA are the 1989 setting out points along the fence of Lot 1169

View from the owner of Lot 1169

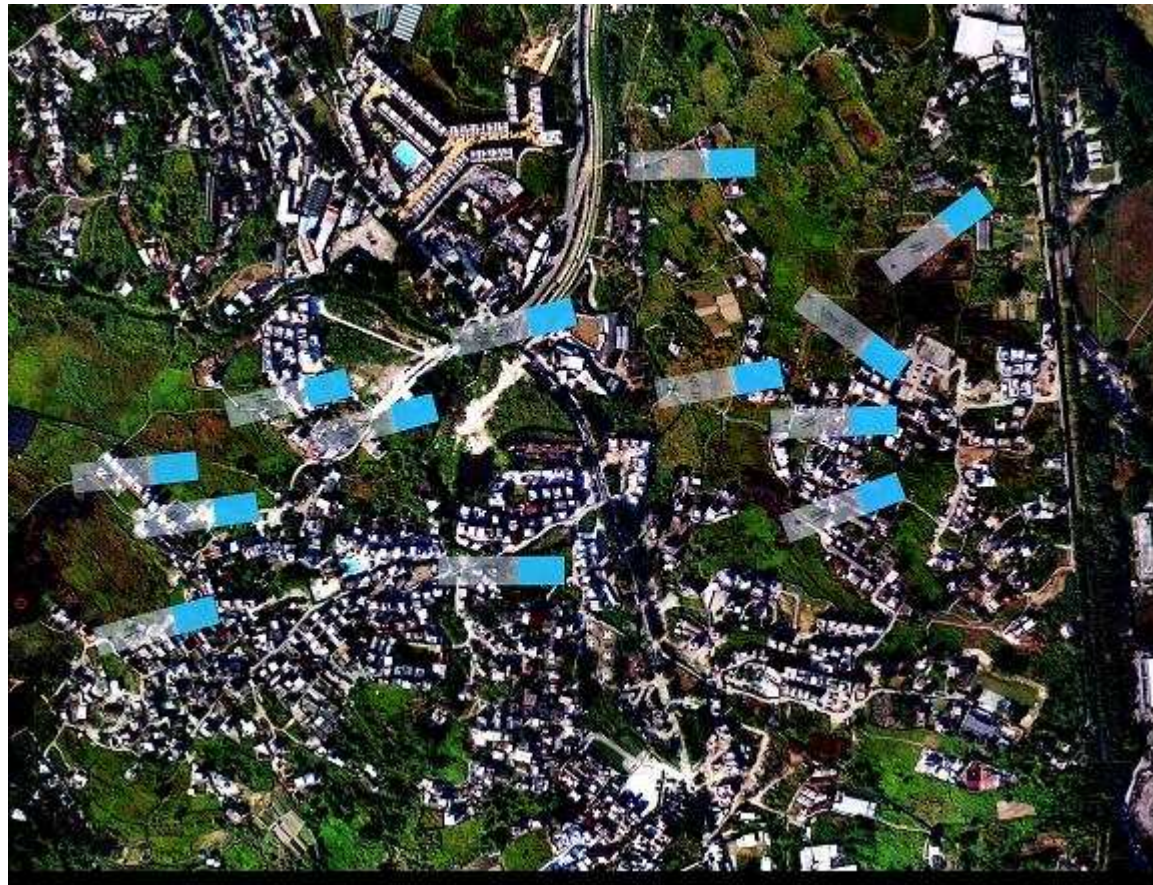
Target points coordinates in 2008

The marked points
are the wells,
road junctions and
bridge pillar
that have
existed till today

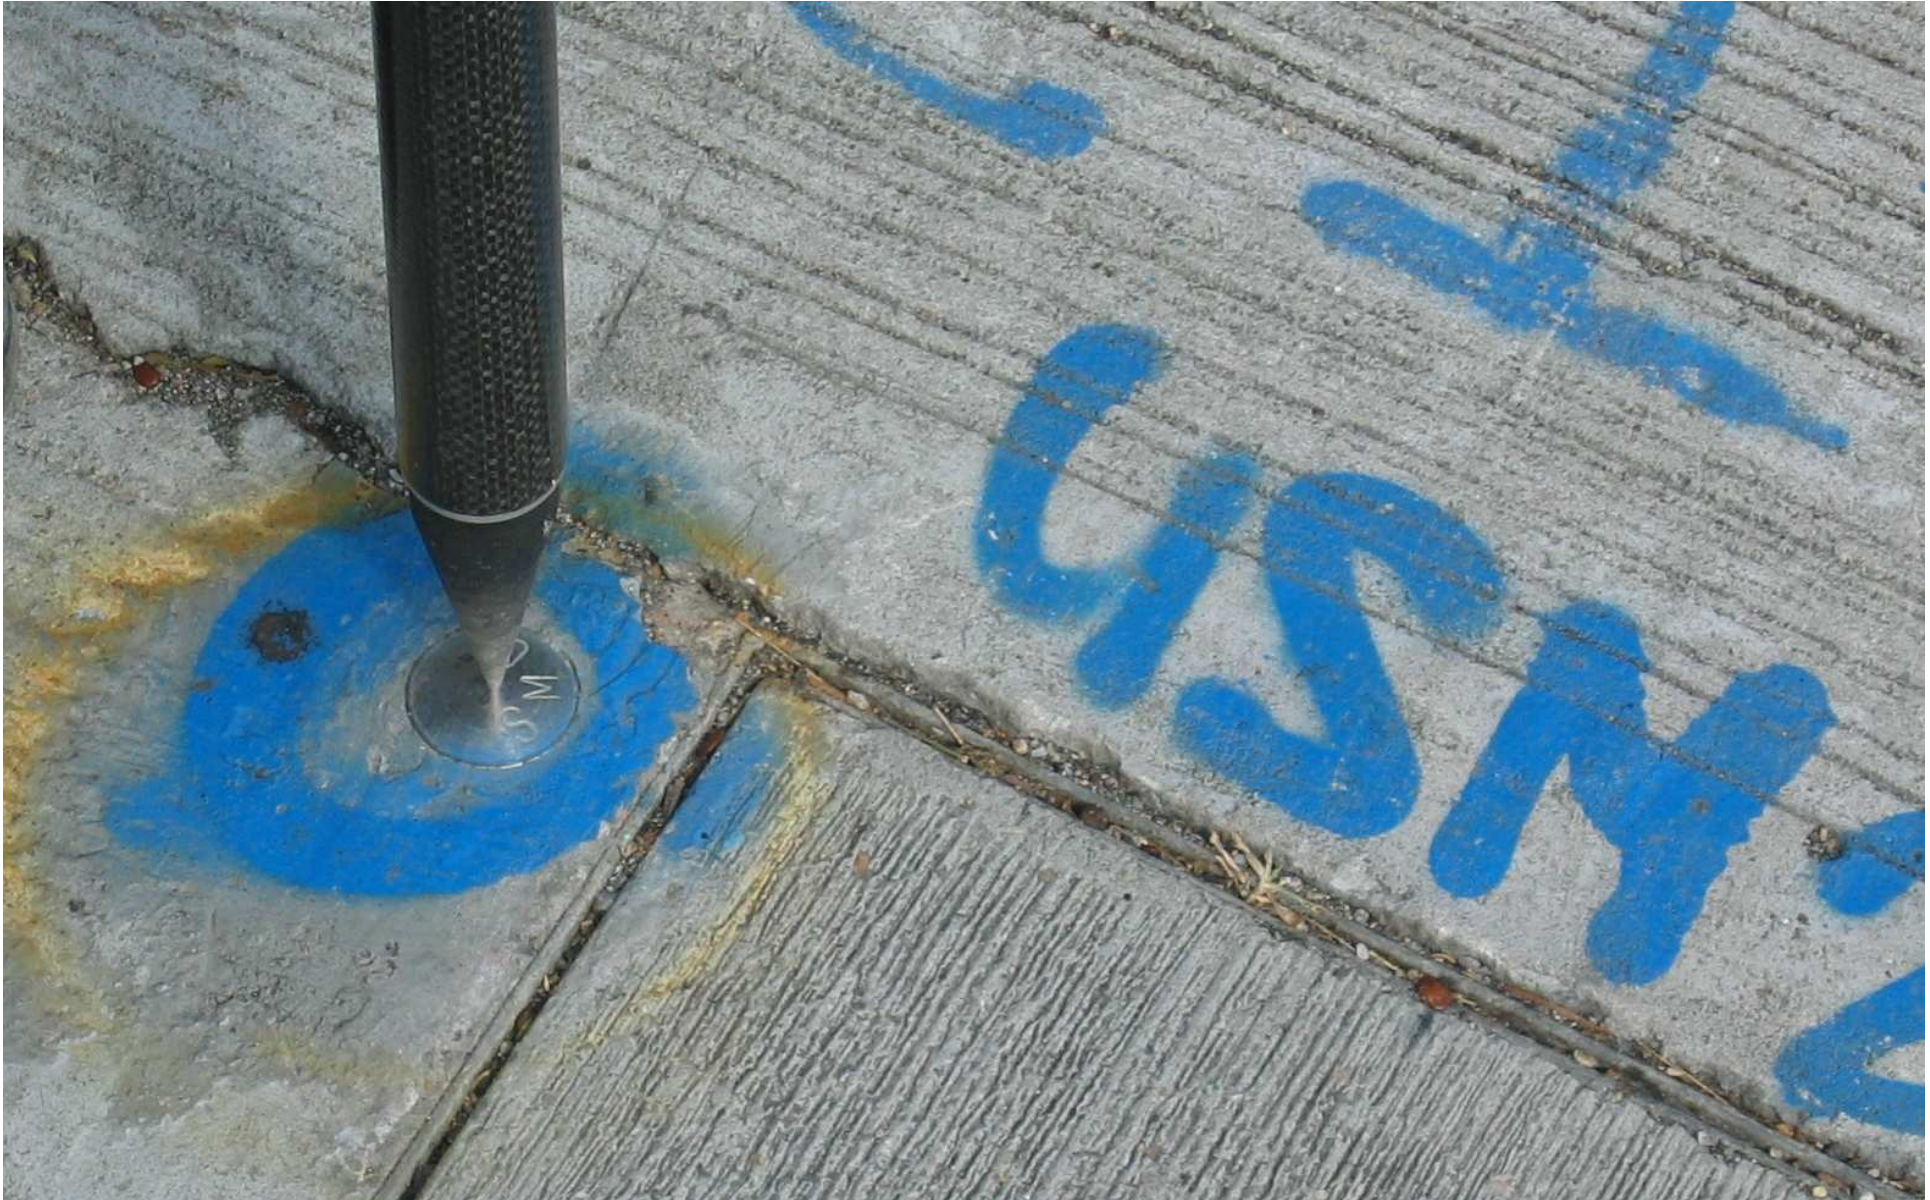
KGPS – accurate to 2 cm

The marked points are surveyed with KGPS

W2 – ‘key-in’ & ‘measured’

Point No.	Northing	Easting	R.L.	Remarks
W1	832548.100	826695.400	18.901	Key-in
W2	832306.200	826661.600	18.901	Key-in
W5	831779.500	826706.300	18.901	Key-in
W8	831569.200	826846.600	18.901	Key-in
W9	831609.000	826922.400	18.901	Key-in
B11	832182.390	826386.571	15.862	
P10	831582.598	826657.810	20.869	
W11	832182.000	826386.900	18.901	Key-in
B4_1	831953.948	826789.359	18.901	
S1_1	832547.315	826695.932	17.109	
USM3	831962.934	826468.215	18.061	3159.026
USM4	831964.916	826469.043	12.209	
W10C	831903.480	826062.070	16.622	
W2_1	832303.529	826661.211	17.134	
W2_2	832302.922	826661.306	17.160	
W2_3	832303.344	826660.686	17.157	
W2_4	832304.047	826661.095	17.154	
W2_5	832303.634	826661.809	17.160	
W3_1	832306.007	826765.062	17.924	
W3_2	832305.861	826764.291	17.927	
W3_3	832306.915	826764.712	15.151	
W3_4	832306.056	826765.861	17.898	
W3_5	832306.713	826765.122	17.916

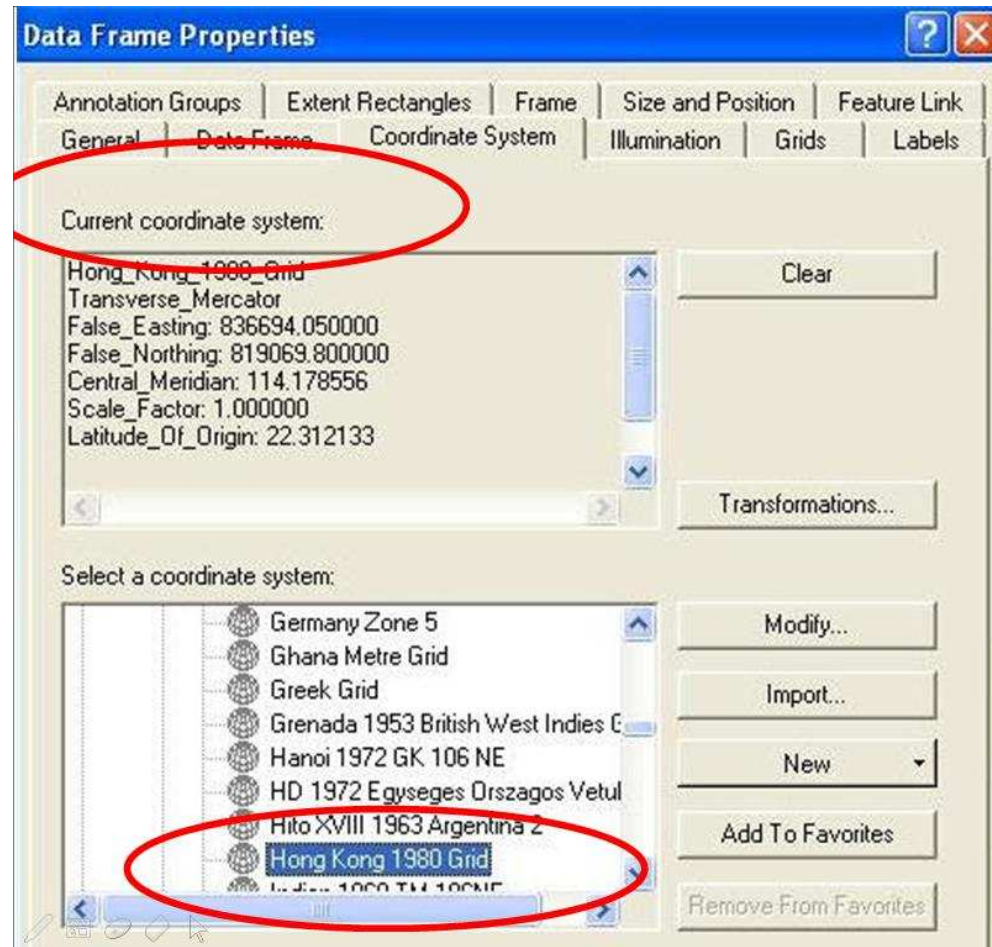
Select a coordinate system in Arc Map

Add 6 control
points in aerial
photo in 1949.

Get the Total
RMS.

Link	X Source	Y Source	X Map	Y Map	Residual
1	2317.261407	-9996.288349	826765.062000	832306.007000	0.22305
2	3290.926370	-9977.112227	826661.211000	832303.529000	0.31394
3	2869.239931	-3807.019585	826708.728000	831642.857000	0.18945
4	1776.294947	-3369.791023	826824.966000	831596.046000	0.20600
5	5885.245135	-8856.088604	826386.571000	832182.390000	0.18121
6	4387.282988	-6949.267446	826546.771000	831978.974000	0.38460

Transformation: &1st Order Polynomial (Affine) Total RMS Error: 0.26057
