# Geophysical Assessment of Dam Infrastructure: the Mugdock Reservoir Dam Case Study

This study investigates for the first time the condition of Mugdock reservoir dam using two different non-destructive geophysical techniques. Electrical Resistivity Tomography (ERT) arrays were installed on the crest to assess the structural integrity of the dam based on the resistivity signatures. Electromagnetic (EM) sensing was then used as a complementary method to confirm the values obtained with the ERT for the upper soil layers of the dam crest.

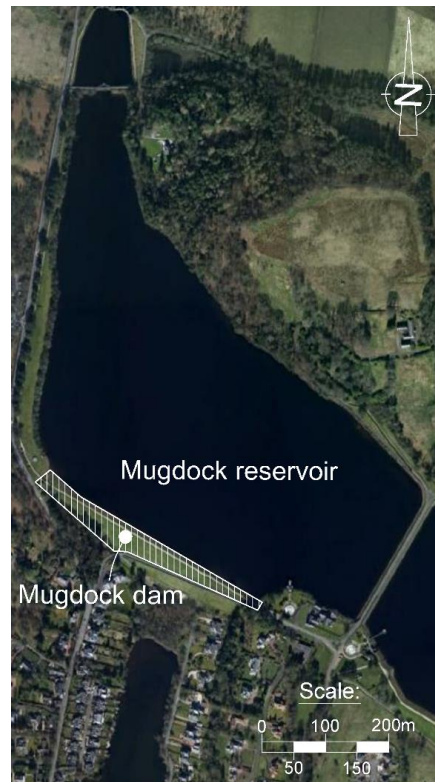
The dam is regulated under the current Reservoirs Act (1975) UK and is categorised as ‘large raised reservoir’ as it is capable of holding 2.200.000 m<sup>3</sup> of water above natural ground level. Mugdock dam, shown in Figure 2, was constructed in 1859 and it is operating since then. The crest length of the main dam is 380 m located on the south side of the reservoir at an altitude of 102 m above mean sea level (AMSL). The maximum height of the dam from the foundation level is 21 m with the top water level at 97.07 m AMSL. The upstream face of the dam is protected against deterioration and wave action with rip-rap.

**Fig. 2** Mugdock reservoir enclosed by an earth-fill dam on the south side.

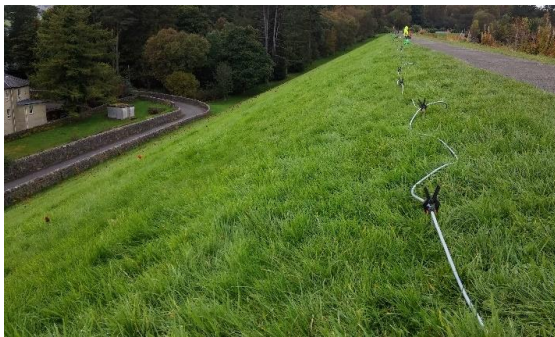
A visual assessment over the crest and the downstream face of the dam was carried out during October 2015 which was provisionally the driest October month since 2003, with 50% of average rainfall. The inspection did not reveal any significant findings and the earth-fill dam had not encountered major deformations or slips. Animal activity was also not evident at the time of the inspection while the crest and downstream face of Mugdock dam appear to be in good condition with healthy short covering of grass (see Figure 3).

**Fig. 3** Views of the crest and the downstream face of Mugdock reservoir dam.

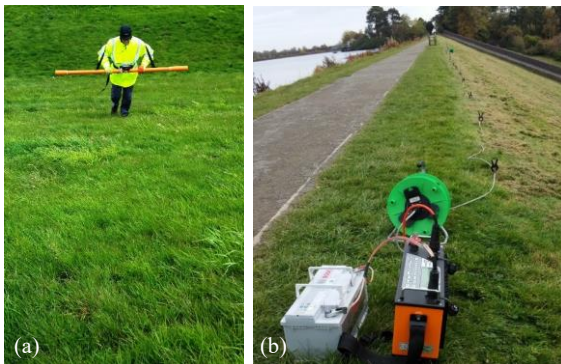
The non-intrusive geophysical surveys aimed at investigating the subsurface conditions beneath the dam crest. Primarily an EM survey was carried out using a CMD unit (GF instruments) scanning the soil conductivity at 3 m depth below the upstream and downstream sides of the dam crest to detect anomalies in the soil layers [see Figure 4(a)].

**Fig. 4** Non-intrusive geophysical investigation using (a) an EM instrument and (b) ERT arrays installed on the crest of Mugdock reservoir dam.

ERT arrays were then installed on the crest of the Mugdock dam as shown in Figure 4(b). All ERT arrays had a length of 96 m with 2 m interval spacing between electrodes that enabled greater penetration depths providing a complete subsurface characterisation of the dam.

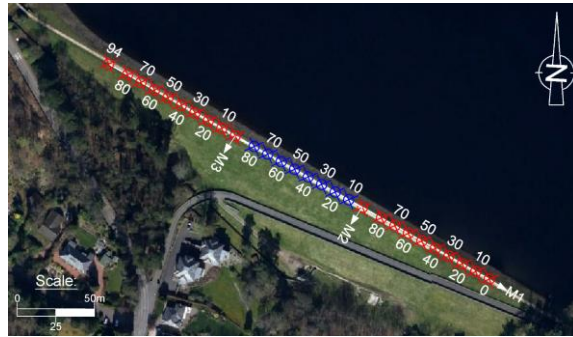
Three ERT arrays (M1, M2 and M3) were installed on the boundary between the south side of the crest and the downstream shoulder of Mugdock dam (see Figure 5). The ERT survey covered the whole length of the dam investigating also the subsurface conditions over its maximum height.

**Fig. 5** Non-intrusive ERT arrays (M1, M2 and M3) 96 m long and 2 m electrode spacing covering the whole length of Mugdock dam.

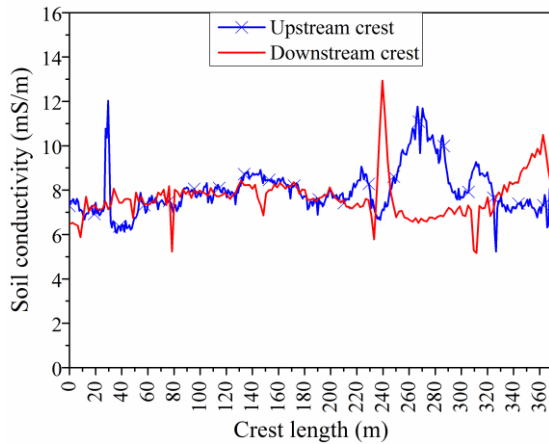
Figure 6 presents the soil conductivity obtained during the EM survey carried out on the upstream and downstream sides of the crest of Mugdock dam. The EM survey did not reveal significant anomalies and conductivity variations are attributed to the interference of obstacles (e.g. metal posts, small concrete areas around geodetic/geotechnical instrumentation). The top layer of the crest consists of soil material with average conductivity of 8 mS/m (resistivity of 125 Ohms.m) which is indicative of clay/sand/gravel soil matrix.

**Fig. 6** Conductivity values obtained during EM survey along the upstream and downstream sides of the crest of Mugdock dam.
