Mapping Water Quality by Using Satellite Imagery

Berk USTUN, Turkey

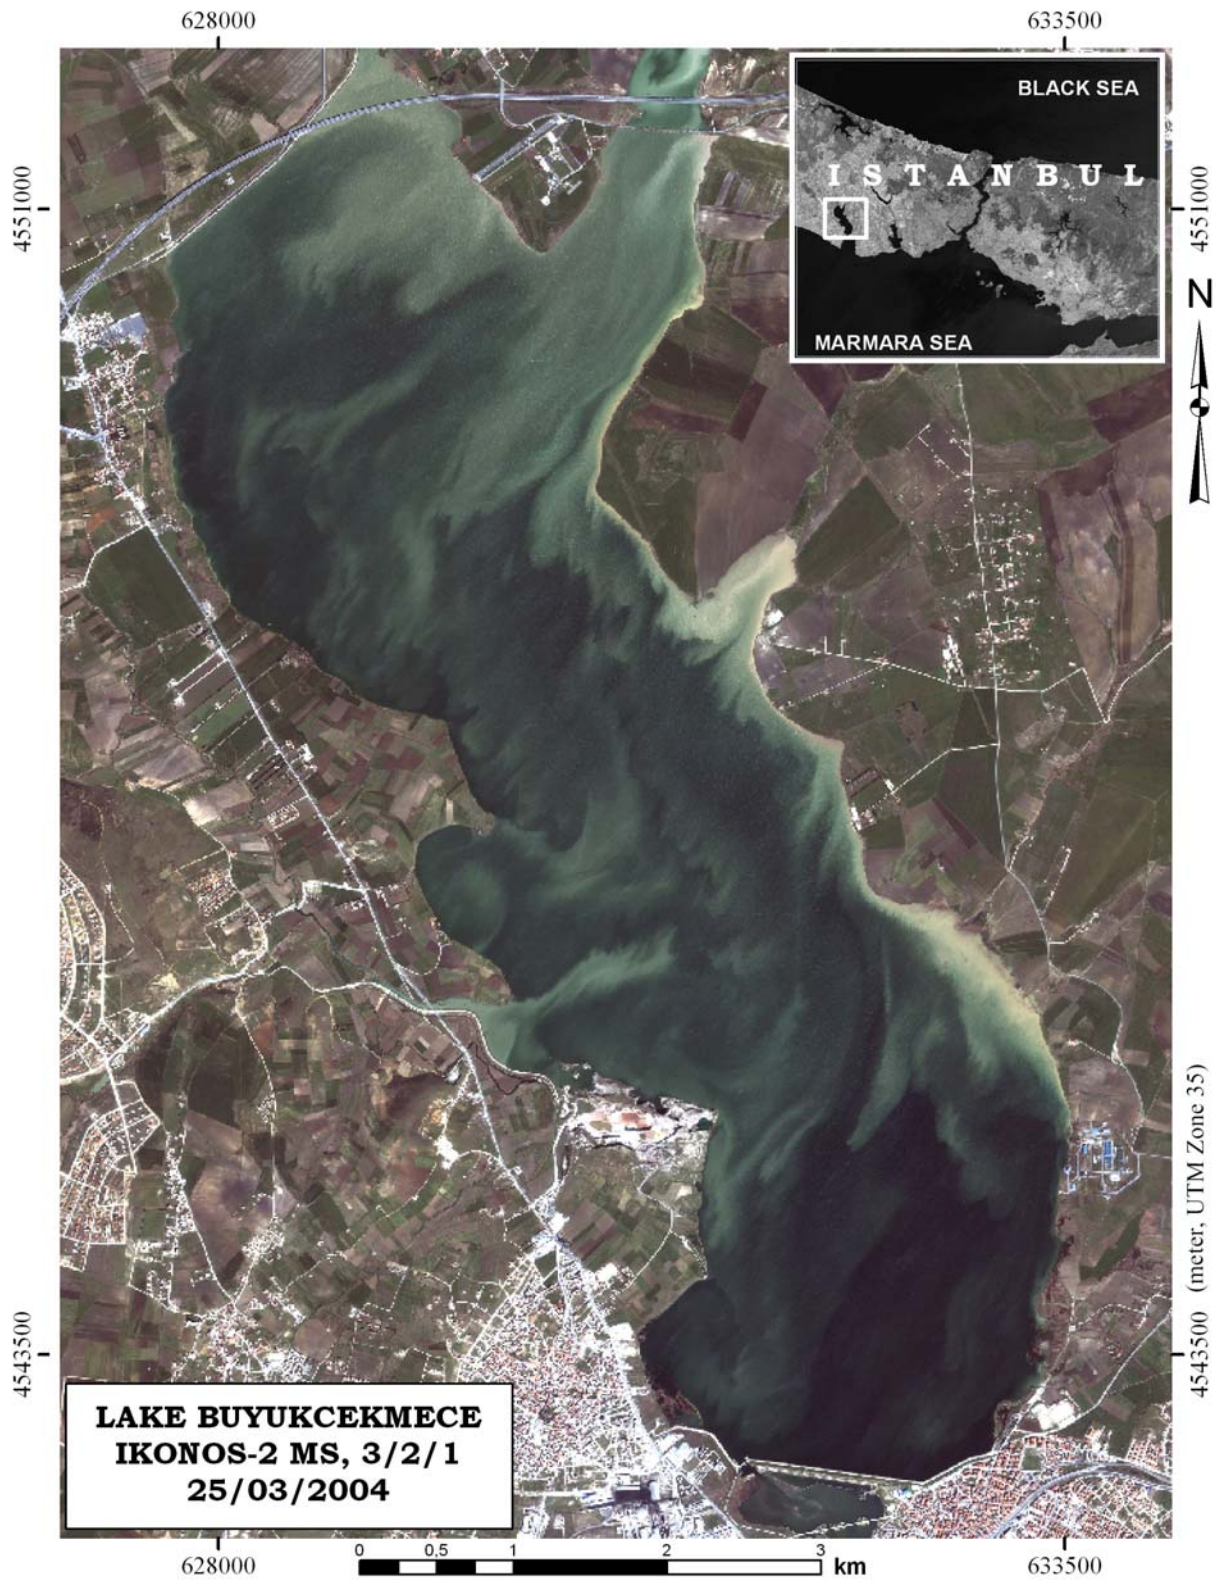
The surface area of the lake is 28.50 km². The studied area captured by IKONOS-2 satellite is located between 28°31'13"-28°31'36"E and 41°06'20"- 41°06'37"N and covers a huge part of the Buyukcekmece Lake with an area of 24.37 km² (Figure 1).
