Detection of Service Pipes and the Risk of Collapsing Sinkholes at the Lake of Constance in Switzerland Using Ground Penetrating Radar (GPR)

Edi MEIER, Inma GUTIÉRREZ, Marco BAUMANN, Max BOSSHARD and Rainer HEEB, Switzerland

FIG Working Week 2019

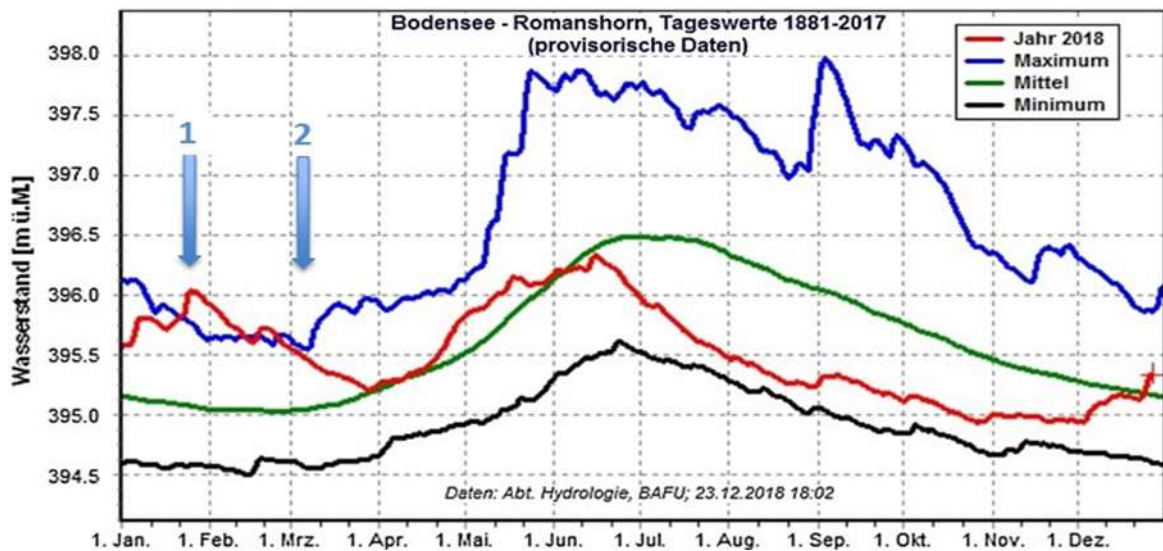
During winter 2018 extreme climatic conditions prevailed in the area of the Lake Constance. At the beginning of February the lake water level was higher than the since 1881 measured data (Fig. 2). Driven by a strong north wind big waves lashed to the shore of the promenade. With temperatures below zero the whole area was covered by a dangerous ice shield (Fig. 3 left).

Fig. 2): Water level fluctuation of the Lake Constance since 1881. Red curve = curve for the year 2018, green curve = mean water level, black curve = min. water level, blue curve = max. water level.

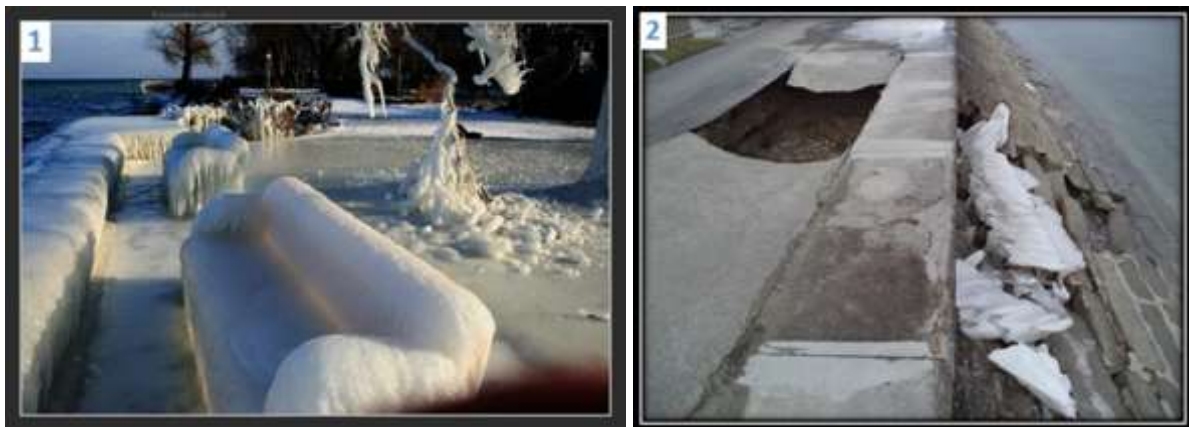
One month later, when the ice melted away, the ground under the fairground plaza and under the pedestrian promenade suddenly collapsed (Fig. 3 right). Only the massive retaining wall did not tumble down and formed a bridge (Fig. 4 left). Apparently, the poor condition of the shore ramp and the high water level - in combination with the strong north wind - was the cause for the soil erosion. The lakewater could penetrate through openings and cracks in the wall (Fig. 4 right) and loosened the ground when freezing.

Fig. 3): Ice shield on the shore in February (left) [4]. Collapsed ground after the melting of the ice in March 2018 (right).

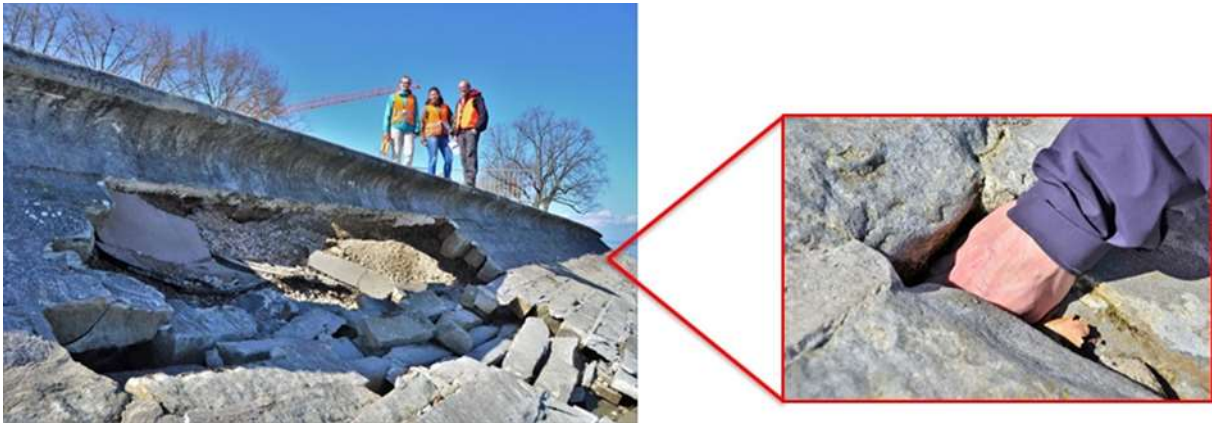
Fig. 4): Collapsed site near the promenade (left). Holes between the stones in the ramp (right).

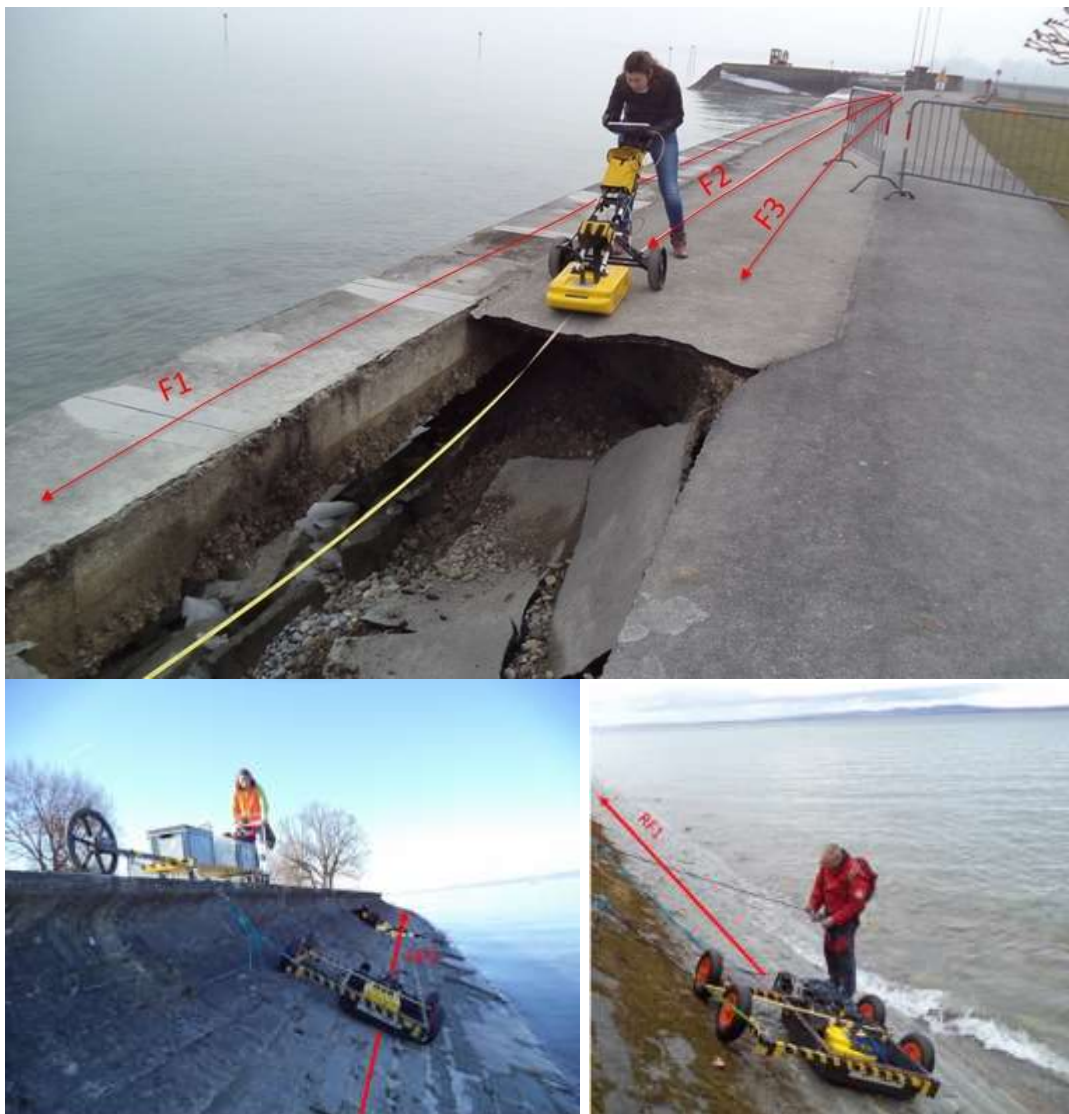
Two areas were investigated: the pedestrian walkway and the fairground plaza, both with associated ramp. The measured data were collected in five parallel rows. During the first measurements, there were still a few icy places on the shore. A GPR system with shielded 250- / 700-MHz double antennas was used (Fig. 5 above).

A week later the two profiles on the shore ramp were executed. For this purpose, two carriages were built, a guiding carriage for the quay wall and a carriage for the ramp wall. They were fixed together with a rope-system.

The guiding carriage was equipped with a precision trigger wheel. This released a measurement every 5 cm interval. The carriage with the radar antenna on the ramp wall was pulled with the same speed as the guiding carriage. Thus, the metering of the ramp profiles is always comparable to that of the profile F1 on the quay wall.

Fig. 5): GPR shots along the promenade: Three profiles on top of the path, view towards the fairground plaza (top picture), two profiles on the ramp wall, view in the opposite direction (pictures below).

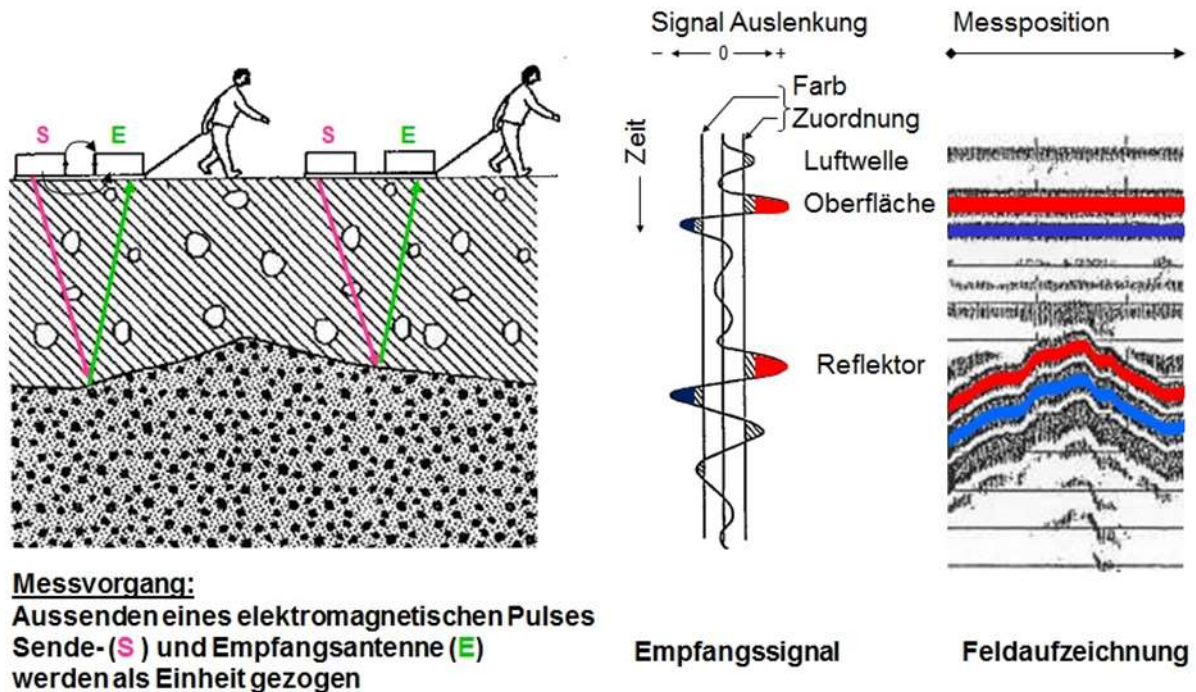
A radar pulse is emitted from the transmission antenna into the ground, which is reflected at interfaces of rock packages or layers in the underground (Fig. 6). Thereafter, the pulse returns to the receiving antenna where it is recorded. The time that elapsed between transmission and reception of the pulse provides information about the depth of the object (reflector). The strength of a reflection serves as a clue to the electrical properties of the material that caused the reflection.

Fig. 6): Principle of GPR measurement (Meier E. et al., 2002)

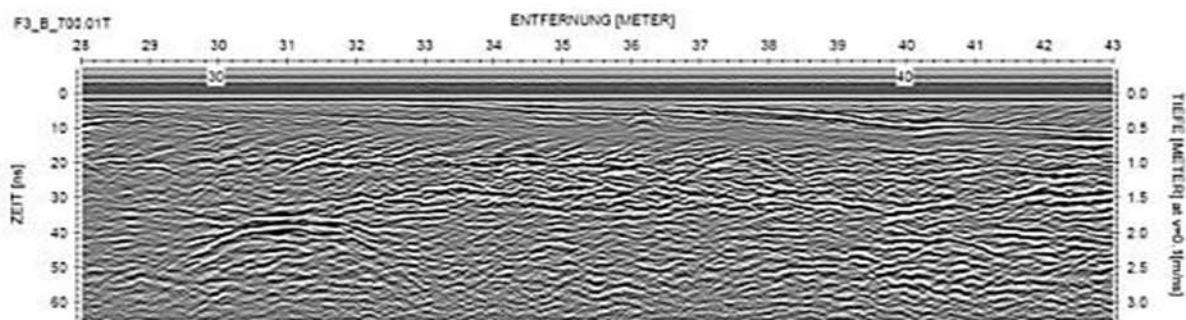
The “radargrams” recorded on the pedestrian path show clear structures up to about 4 m depth. Profile F3 was taken at a distance of 2 meters parallel to the quay wall. Figures 7 and 8 show the same section as profile F3, but were recorded with two different frequencies. While the 700 MHz antenna shows smaller structures (Fig. 7), the 250 MHz antenna achieves greater depth penetration (Fig. 8).

Fig. 7): Part of profile F3, taken with the 700 MHz antenna.

On both pictures is the same structure clearly visible: a structure up to 1 m depth, that slopes to the left, is seen on the left half on the “radargram” as well as the departure tracks of the construction machines on the right half.

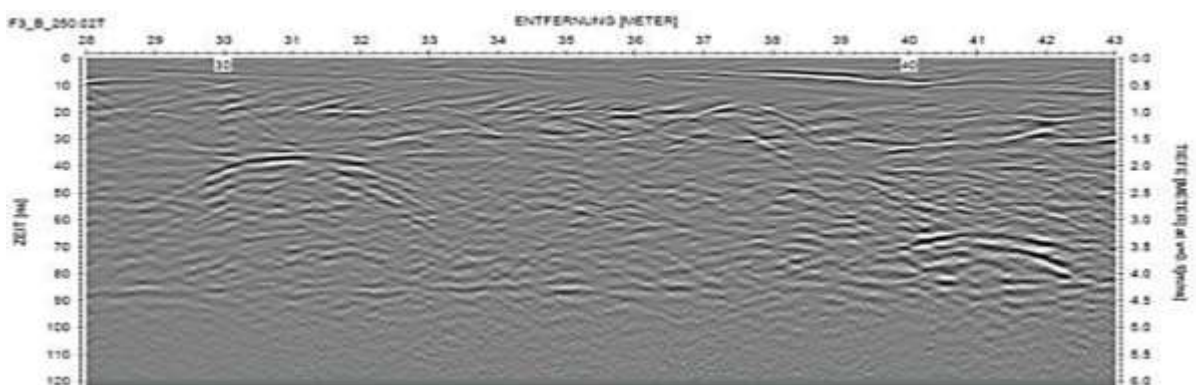
Fig. 8): Part of profile F3, taken with the 250 MHz antenna.

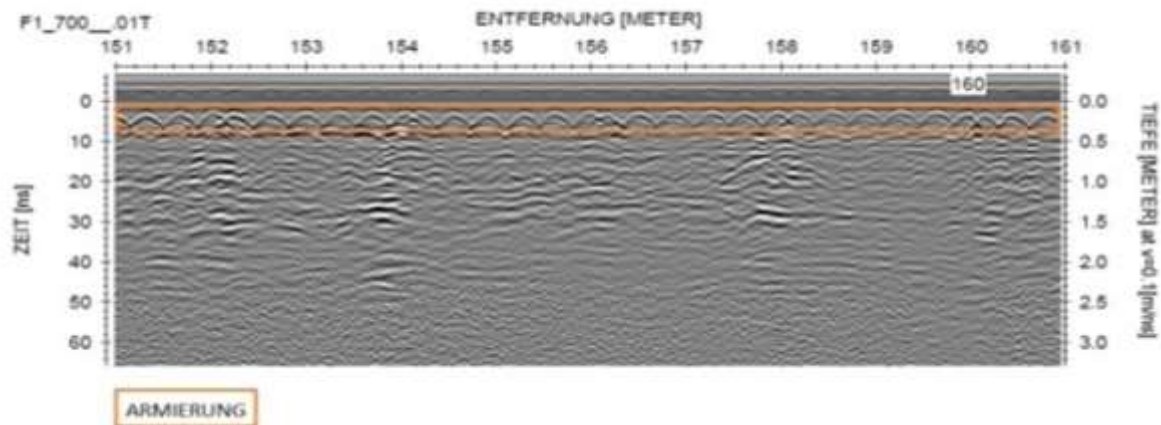
receiving antenna. In the “radargram” it is displayed perpendicular to the profile. This leads to the above-mentioned “bow shape” (hyperbolas). This can be seen on the “radargram” of profile F1 taken on the Quay wall: there is a regular pattern of hyperbolas (Fig.9). Four transverse reinforcing bars per meter create this pattern. The hyperbolas in the “radargram” simulate a continuous arcuate support structure, that certainly does not correspond to the reality. In fact, the “reinforcing bars” are likely to be only a few cm in width.

Fig. 9) Part of profile F1 on the quay wall, taken with 700 MHz antenna. Reinforcing bars draw hyperbolas in the “radargram”. At the apex of each hyperbola is a “reinforcing bar” in transverse direction to the profile.

To correct these "artefacts" the geophysical processing method "migration" is used. This method recalculates the hyperbola branches to a circle, the actual origin of this object. However, migration only makes sense if the hyperbolas cover underlying structures or if steep structures are present. We recommend to keep the hyperbolas in the “radargram” and to analyse them. The position and depth of the object can be determined just as well without migration, because the objects are always at the vertex of the hyperbola.

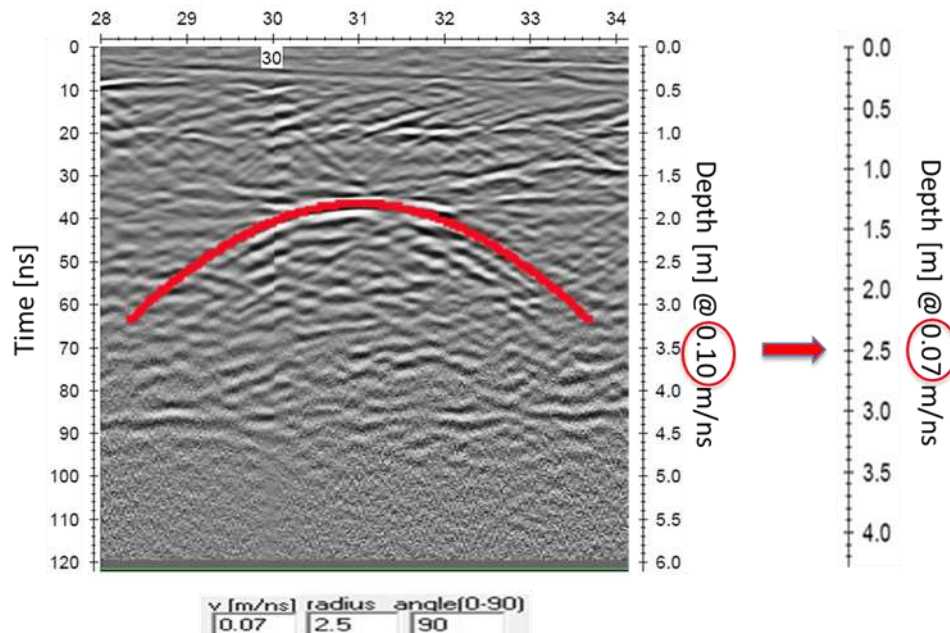
As an example, the analysis of the object in 2 m depth at profile position 31 m in the radar profile F3 is shown in Fig.10.

Fig. 10): Model hyperbola adapted to the object in Fig. 8. The depth scale on the right corresponds to the calculated speed of 0.07 m/ns adapted in the model.

The model hyperbola gives a speed of 0.07 m/ns. The depth scale must therefore be corrected at this point by a factor of 0.7. This slower speed indicates that clayey material has been deposited over the object. The model calculation of the value of the diameter of the object gave a result of 2.5 m. However, it could also be an elongated object (pipe) cut at a shallow angle. This would result in a comparable flat model hyperbola. Since the object is not seen in the neighbouring profiles, this interpretation is much more likely. A cavity washed out by the lake can thus be excluded.

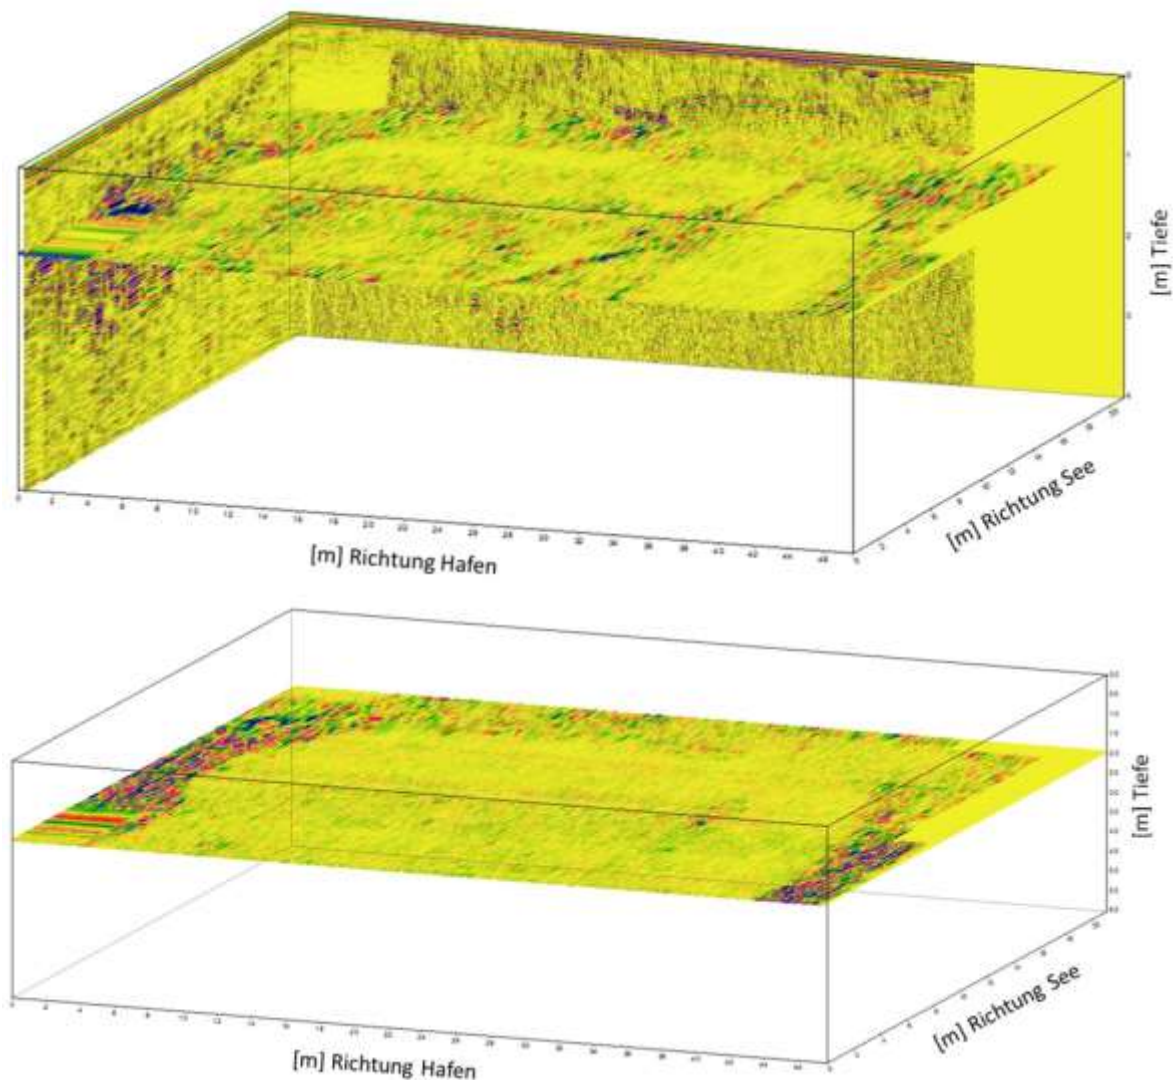
The 50cm line grid recorded on the fairground plaza allows both a 3-D interpolation of the ground in the longitudinal and transverse directions as well as a plane representation with depth (see Fig. 11). These pictures are “put together” in the form of a film document. It can be played on any video player program and stopped at any depth. In the plane view, in 1.1 m depth, lines (=pipes) can be seen, which are shown as a “Y-shape”. At a depth of 2 meters you can see a dense track in the middle of the area and at the margin a deposit of landfill material is assumed, because all the area is artificially filled up. On the basis of these findings, dredging slits were executed to corroborate the interpretation.

Fig. 11): 3-D images: In the plane view, lines are visible as a „Y-shape“ in 1.1 m depth. The lower picture shows the level at a depth of 2 m. Here, especially on the left and right side of the area, there are highly reflective zones.

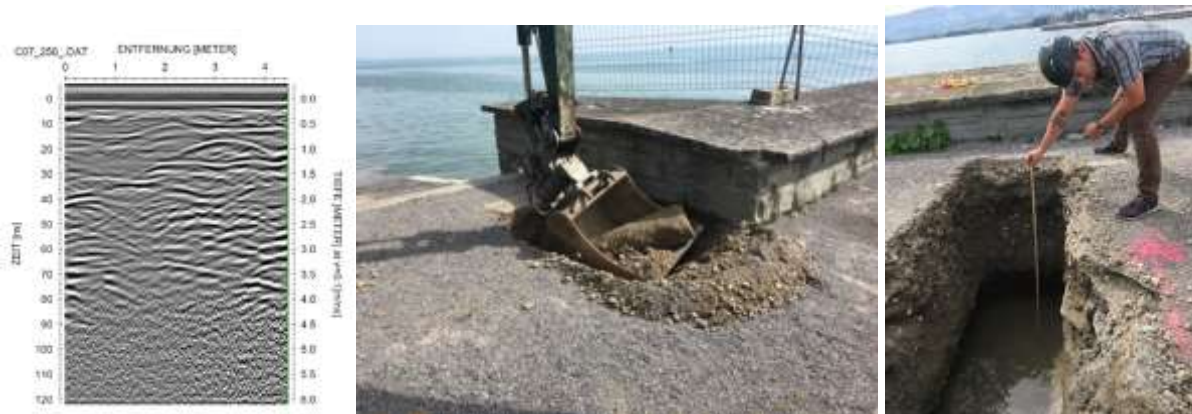
The dredging slits to the left and right of the site did not show the expected clayey landfill material. At first a large block of stone appeared, which caused the hyperbola (Fig. 12, left and center). Below the stone there followed potato-sized, round stones without finely granulated material. Water immediately flowed through the large cavities between the stones, (Fig. 12, right), which explains the change in the reflection signals at a depth of 2 meters. This shows that there is a rapid hydraulic connection to the lake water on the edge of the plaza and that a lot of fine grained material from the original fill is washed out. With great certainty it could be ruled out that the ground on the plaza would suddenly collapse. At the most, slow subsidence can occur when more fine grained material is washed out.

Fig. 12): The Profile C7 has a distinct hyperbola (picture left). The excavation brings out a large stone block (middle picture). The remaining excavated material consists of round stones of 3 - 5 cm diameter with little finely granulated material. The water flows immediately (picture right).
